Integrity Municipal Systems Restores Bulk Emergency Chlorine Vapor Scrubber System for City of Tulsa, Oklahoma

As part of a major modernization of the Mohawk Water Treatment Plant in the late 1990s, the City of Tulsa, Oklahoma, installed a bulk emergency chlorine vapor scrubber system. This standby equipment, which is critical to the overall safety plan of the plant's chlorine gas disinfection system, uses liquid caustic soda to neutralize chlorine gas in the event of an accidental release.

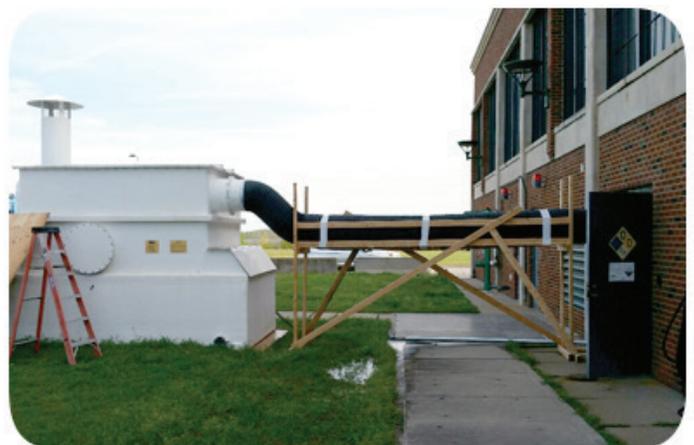
Temporary emergency chlorine scrubber provides protection during rehabilitation

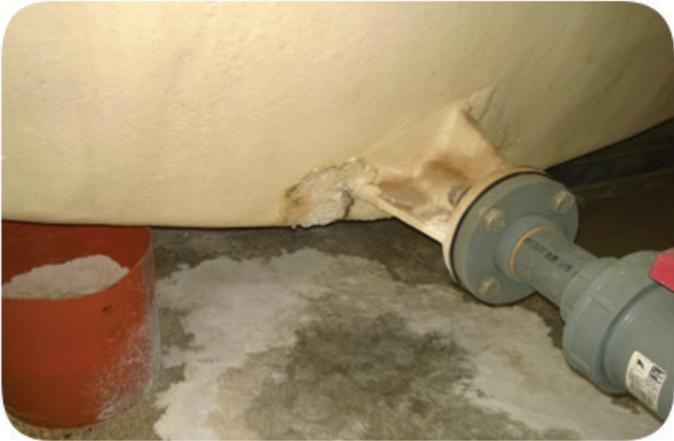
BEFORE

Leak at storage tank drain

In addition to relining the storage tank, IMS upgraded to FRP the recirculation pump discharge piping, installed a new access manway in the tank sidewall, upgraded the internal liquid distributor design, removed the tank drain to minimize susceptibility to leaks, and replaced wear parts such as gaskets, fan belts, and instrumentation. All FRP surfaces were then recoated with gelcoat and all pumps and the fan were painted.

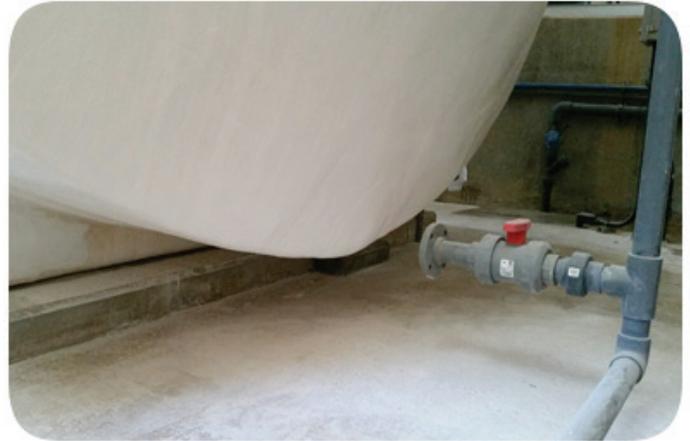
AFTER

Leak fixed and drain plugged to minimize future leaks

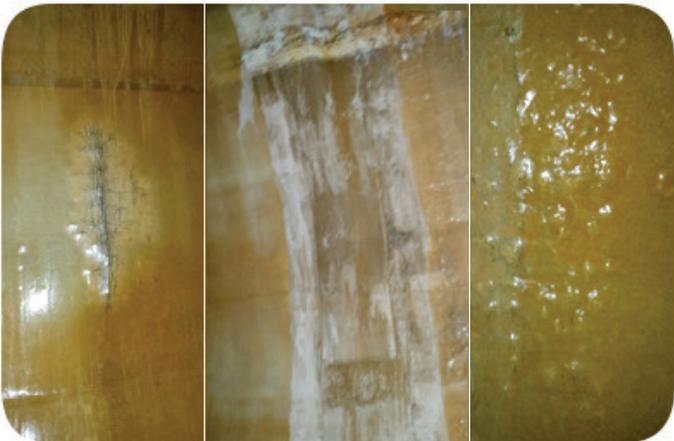
After removal of the caustic solution, the scrubber system was acid washed to remove caustic solids and inspected by an independent FRP inspector. The portion of the storage tank in direct contact with caustic was severely corroded and required significant rehabilitation. Based on the recommendations of the FRP inspector, IMS ground down and repaired all raised surfaces, blisters, and surface cracks in the storage tank, and relined almost the entire corrosion barrier.

Severe corrosion to storage tank interior – sample close-ups of 3 locations

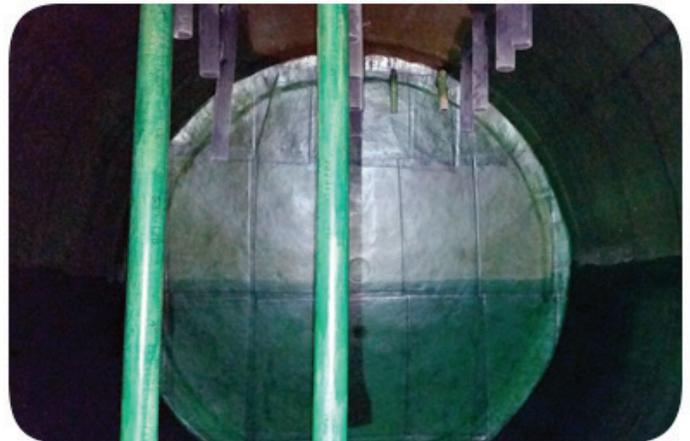
Before transferring and filtering the stored caustic back into the rehabilitated scrubber system, the FRP inspector returned to evaluate the repairs. All work was found to be properly completed and in excellent condition. The inspector's final report concluded that the refurbishment of the system should increase the service life of the tank by another 15 to 20 years, far exceeding original expectations.

Storage tank interior after repairs and relining
