## **Integrity Municipal Services Successfully Reconditions 15-Year-Old Emergency Chlorine Vapor Scrubber System for the Oglala Sioux Rural Water Supply System in South Dakota**

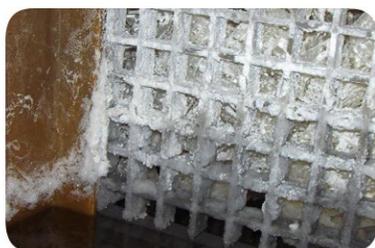
*Packed Bed Before Acid Wash*

1. Removal of spent caustic;
2. Addition of muriatic acid to breakdown and neutralize solids;
3. Running the recirculation pump to circulate acidic solution through the system in order to wash the scrubber packing media and liquid distribution piping;
4. Removal, cleaning, and reinstallation of spray nozzles; and
5. Removal, neutralization, and rinsing of all internals with fresh water.

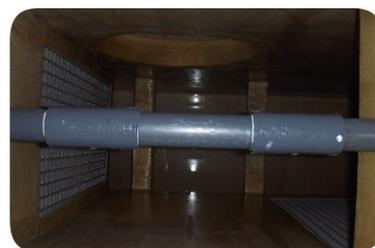
*Packed Bed After Acid Wash*

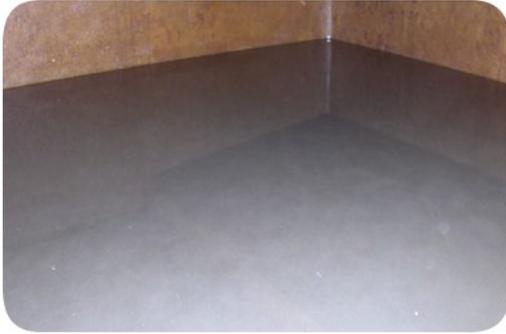
**BEFORE ACID WASH**

During a preliminary site visit in August 2014, an Integrity Municipal Services (IMS) inspector determined that the plant’s EVSS had approximately “12 inches of caustic solids built up in

the scrubber sump with an appearance of a clear block of ice.” The existing liquid caustic was foaming and pushing residual out the top of the recirculation pump.

Clear 12" Block of Caustic Solids

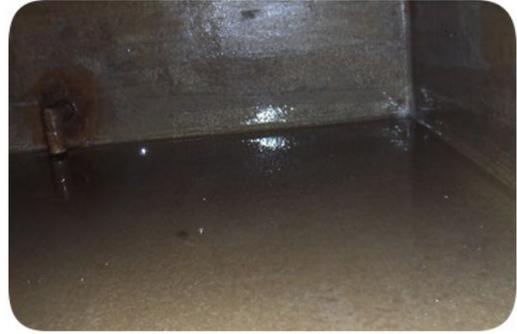
**AFTER ACID WASH**

Sump After Acid Wash

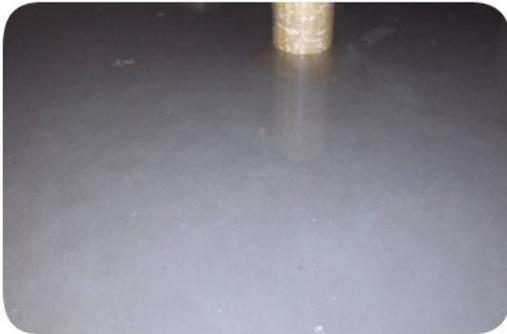
Sump Before Acid Wash

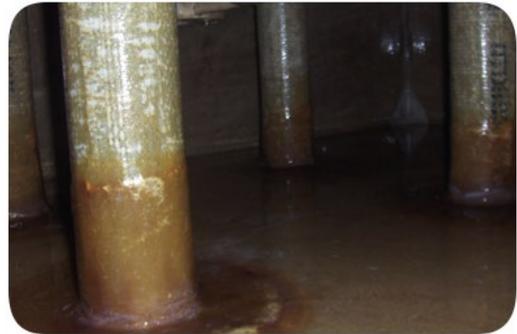
Sump After Acid Wash
