Integrity Municipal Services Successfully Reconditions 15-Year-Old Emergency Chlorine Vapor Scrubber System for the Oglala Sioux Rural Water Supply System in South Dakota

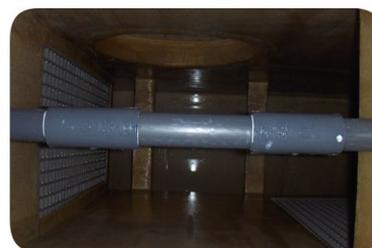
Packed Bed After Acid Wash

1. Removal of spent caustic;
2. Addition of muriatic acid to breakdown and neutralize solids;
3. Running the recirculation pump to circulate acidic solution through the system in order to wash the scrubber packing media and liquid distribution piping;
4. Removal, cleaning, and reinstallation of spray nozzles; and
5. Removal, neutralization, and rinsing of all internals with fresh water.
