Integrity Municipal Services Successfully Reconditions Emergency Chlorine Vapor Scrubber at RL Sherard WTP in Wyoming

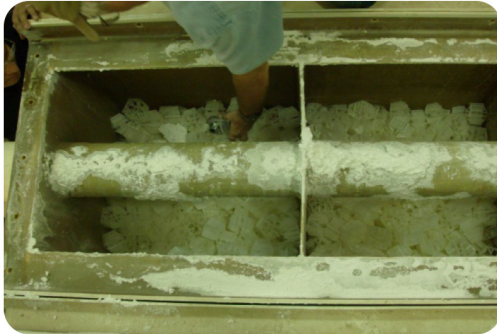
BEFORE ACID WASH

Packing in Second Stage

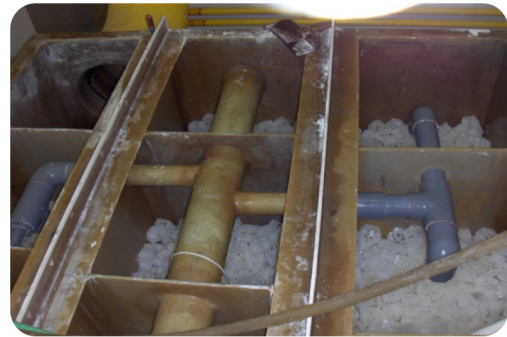
AFTER ACID WASH

Packing After Acid Wash

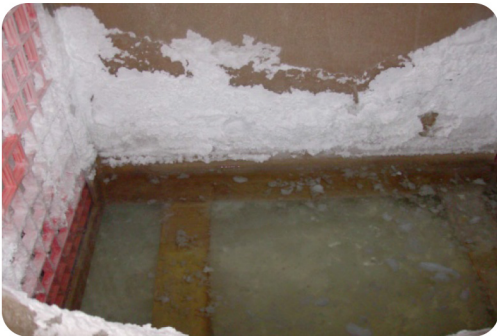
Solids in Sump Up to 29" Thick

spent caustic and acid wash solutions that would be generated from the cleaning process on-site in the nearby sludge holding pond where a pH in the range of 6-9 was acceptable. Utilizing onsite disposal instead of traditional removal and disposal at qualified facilities provided substantial savings for BOPU. In November 2011, IMS personnel performed the acid wash of the system. The cleaning process included: (1) removing as much of the existing liquid caustic solution as possible from the scrubber sump, neutralizing and disposing of it onsite, (2) dissolving solids buildup in the sump with muriatic acid, (3) recirculating acidic solution over the packing media to dissolve solids buildup and increase pH, (4) cleaning the spray nozzles, and finally, (5) removing the acidic solution from the sump, neutralizing and disposing of it. The system was thoroughly rinsed with water prior to the final inspection of all components.

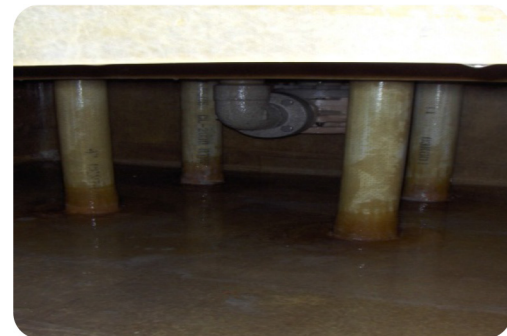
Sump After Acid Wash

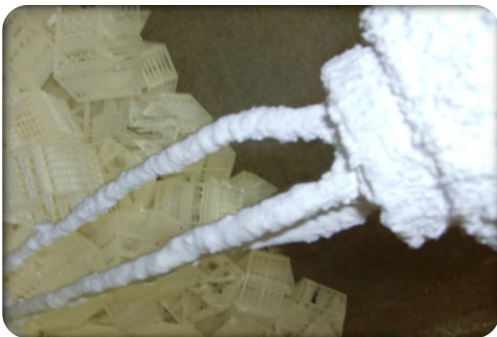
Nozzle in Second Stage

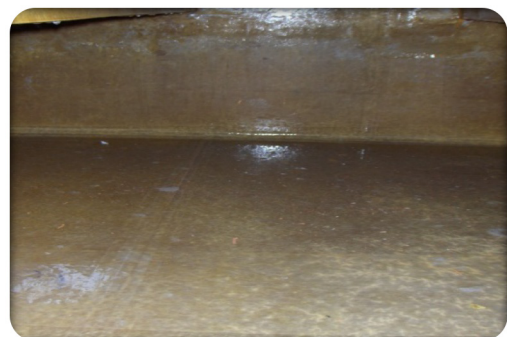
Sump after Acid Wash
